Troubleshooting Wireless Clients

Version 1.1

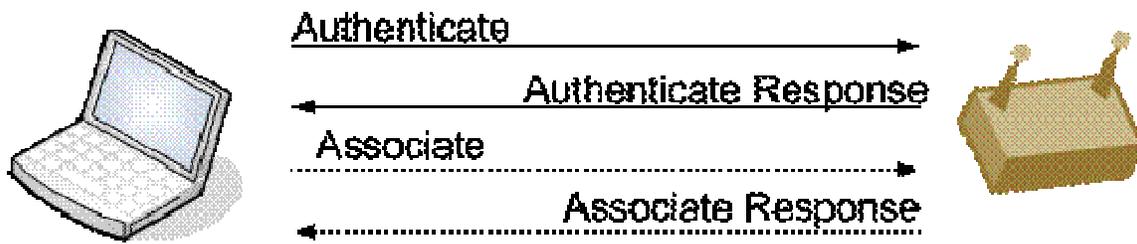
Figure 2 - Association Process

After a client has located one or more APs supporting the desired ESSID, it must associate to that AP. Association is a four-step process consisting first of 802.11 authentication (not to be confused with 802.1x or VPN authentication) followed by association. Four frames are exchanged on the wireless network during association, as shown in the figure below.

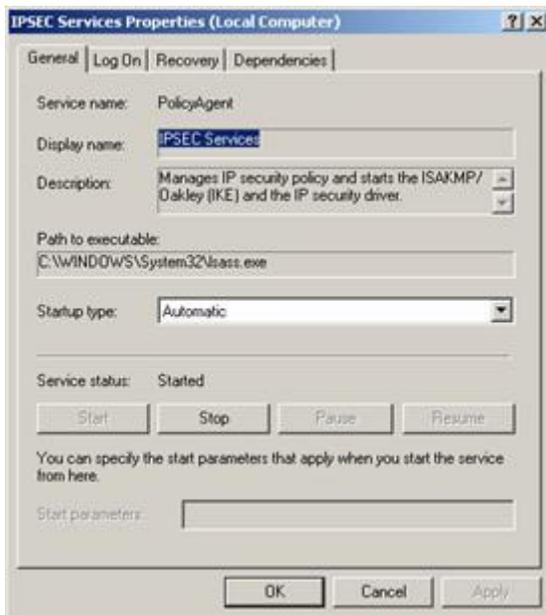
Figure 4 - Windows IPSEC Service

- One possible cause of this problem is a lack of IP connectivity to the Aruba switch. It is unlikely that this is the cause when the client is attempting a VPN connection to the switch with which it is associated. However, the VPN client is sometimes used across multi-hop IP networks. If this problem appears, it may mean that the client has an IP address and a default route, but an upstream router does not have a path to the VPN termination point.
- Another possible cause of this problem is that the Windows IPSEC service is not running. Bring up the Windows “Services” control panel by navigating to Start □ Settings □ Control Panel □ Administrative Tools □ Services. Look for the IPSEC service, and verify it is configured as the following figure shows. Note that the IPSEC service in turn depends on the Remote Procedure Call (RPC) service - verify that both are enabled.
